Inspection Report

**Property Address:
2007 Skinner Road
Winter Park, FL 32792**

Date: 9/3/2007	Time: 12:32 PM	Report ID: 080107-2
Property: 2007 Skinner Road Winter Park, FL 32792	Customer: William Thompson	Real Estate Professional: George Smith Sample Realty

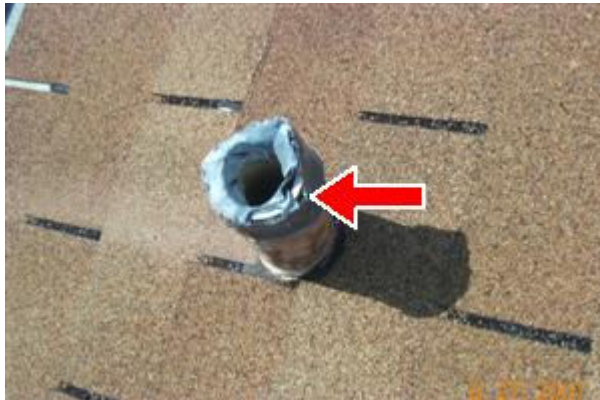
1.2 Picture 1

The plumbing vent pipe boot flashings are damaged and need to be replaced. Damaged boot flashings will allow rain to run down the side of the pipe and enter the homes walls where it can cause unseen damage. Recommend replacement by a licensed roofing contractor.

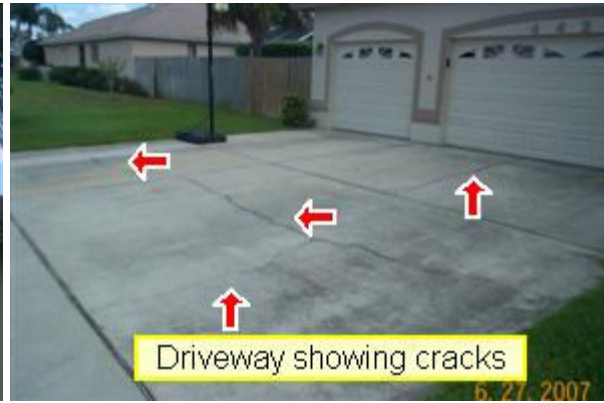
The driveway is exhibiting cracks that are consistent with the age of the structure. The driveway appears to be functional at this time. The cracks should be monitored and repaired as needed.

The tree limbs that are in contact with roof or hanging near roof should be trimmed.

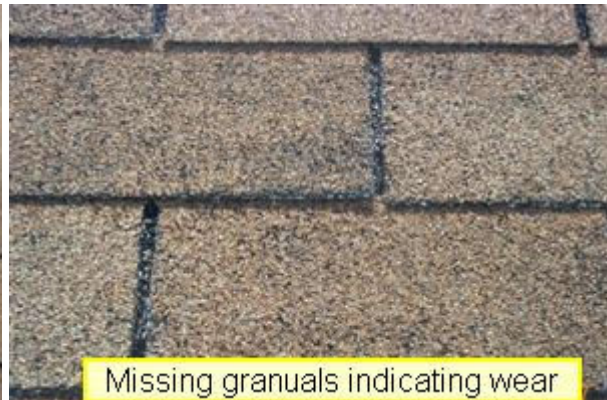
The roof covering shows signs of wear in several locations. The client should plan on replacing the roof covering in the near future to prevent possible leaks. **I recommend having a licensed contractor evaluate the roof covering for a more precise estimate of the remaining life.**

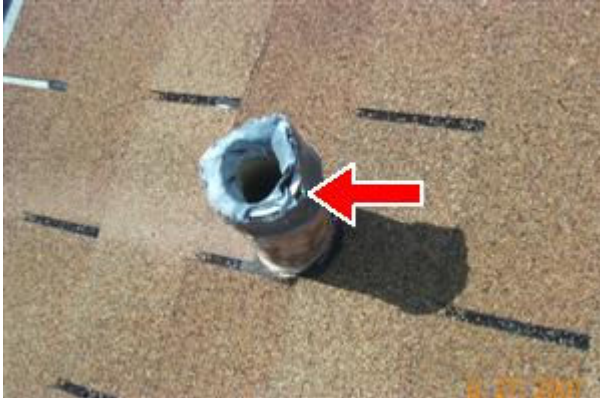
1.2 Picture 1

- 🏠 The plumbing vent pipe boot flashings are damaged and need to be replaced. Damaged boot flashings will allow rain to run down the side of the pipe and enter the homes walls where it can cause unseen damage. Recommend replacement by a licensed roofing contractor.
